CASE STUDY

DRYING AND COATING CONCRETE AT THE NATIONAL AQUARIUM

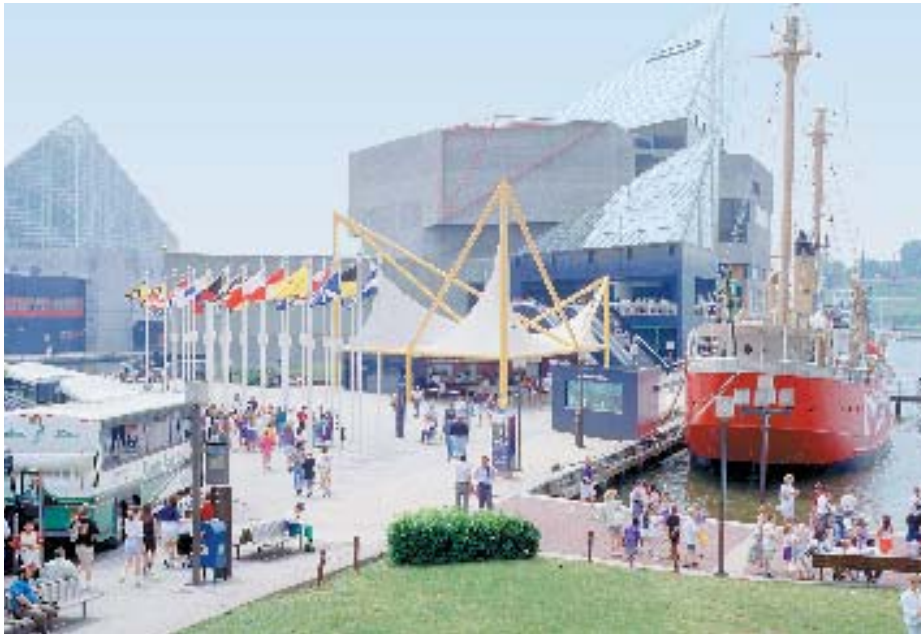
Above: At the National Aquarium in Baltimore, Munters Moisture Control Services let the contractor dry out wet concrete quickly, improving adhesion and keeping the project on-schedule and on-budget.
