CASE STUDY

BIOLOGICAL HAZARD ABATEMENT: DRYING SAVES 42 BUILDINGS IN CSU FLOOD RECOVERY — FORT COLLINS, COLORADO

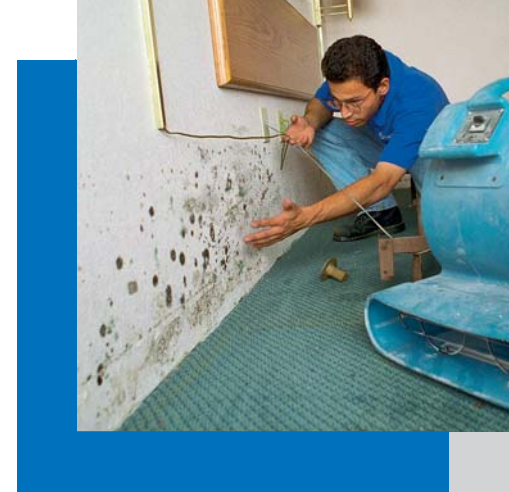
Munters MCS was at CSU drying for just 22 days. Munters quickly assembled a massive drying system to prevent hazardous biological growth and save building materials. The dehumidifier shown in the picture can remove up to 800 gallons of moisture each day from walls, carpet and structure.

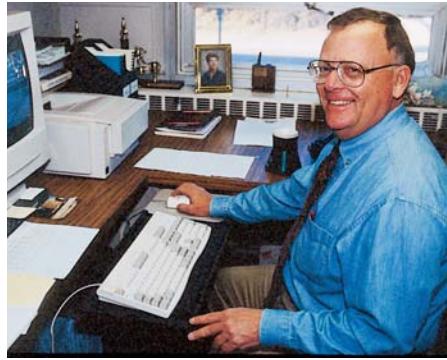
Ron Baker, director of facilities at Colorado State University, had to get 42 water-damaged buildings dried and open for the impending return of 23,000 students. “Munters helped check a bad situation that could have gotten rapidly worse,” said Baker.

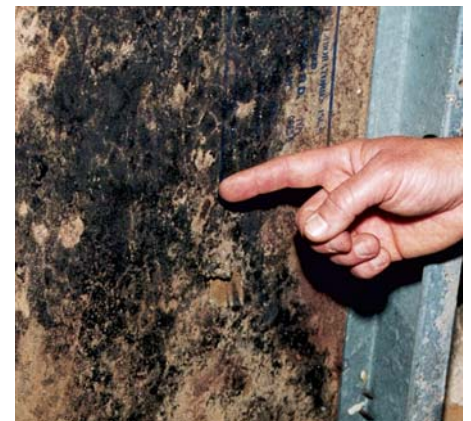
After flooding at CSU, 42 buildings were threatened by contamination from mold, mildew and other microbiological organisms. Munters controls mold and microbial growth after floods by drying buildings with an advanced method called desiccant dehumidification. Desiccant dehumidification restores the buildings by “pulling” moisture out of wet structural materials using dry air. This prevents mold and mildew from growing.

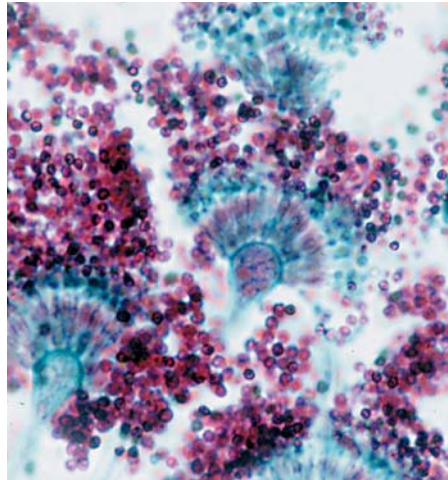
Fungi, such as Aspergillus, can quickly cause musty odors, signaling its presence after flooding. Some fungi may lead to allergic reactions, illnesses and even death if left unchecked.
