CASE STUDY

MULTIFACETED PROJECT: DALLAS RADISSON STAYS IN OPERATION AFTER FLOODING CRISIS

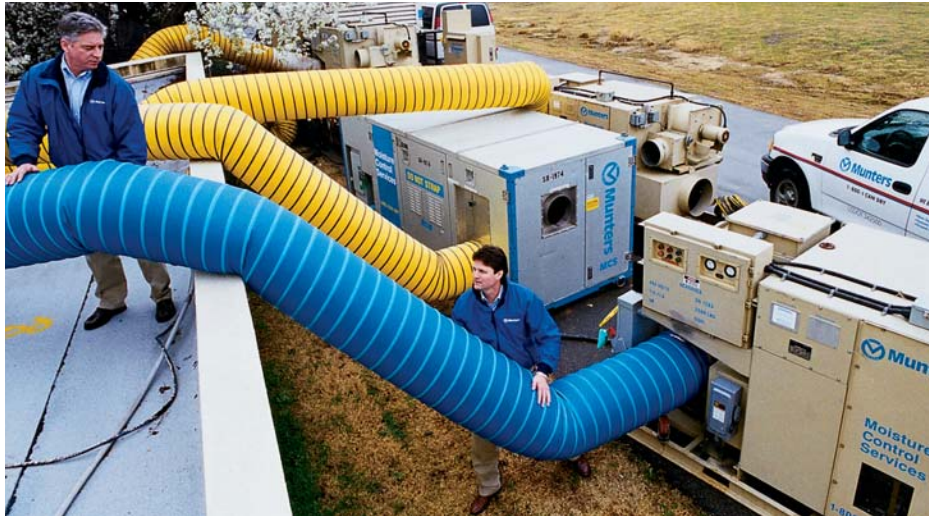
Four of Munters M-20 dehumidifiers were configured to deliver dry air to eight floors at the Dallas Love Field Radisson, after a pipe break in the North Tower. The hotel's chief engineer, Jim Holmes (above right), said Munters helped keep the hotel in operation with a fast response after the water damage was discovered.

"We got the call on Friday night," said Randy Webb, Munters account manager. "We did an assessment and began moving equipment to the site the same day. By Saturday, we had four of our largest dehumidifiers set up with 200 air movers in a unique configuration engineered to get dry air to eight floors simultaneously."

Munters located the drying equipment outside the building. It then built a network of flexible duct that brought the dehumidified air up through the stairwells and then onto each floor. Air movers and ancillary "layflat" ductwork took the air into each of the guest rooms.

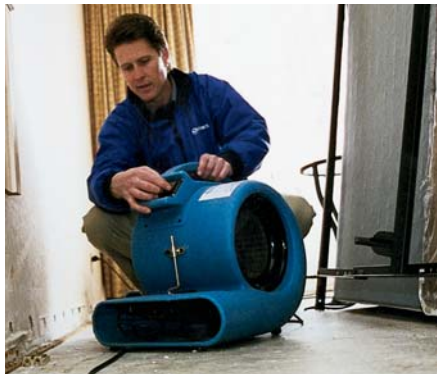
Munters delivered dry air into each of 90 affected rooms with a complex system of dehumidifiers and air moving equipment. No sheetrock had to be replaced; and furniture and carpet were saved. Mold and mildew growth was held in check as well.

The system filled the building with air that had a relative humidity of 10%. This created desert-like conditions inside, while the outside weather was cold and damp. As a result, the moisture on the surface of the sheetrock, carpet and concrete was absorbed by the air, which was then expelled.

Then, over a eight-day period as more dry air was continuously circulated, moisture was removed from deep within wet objects and structure. This procedure dried the building completely.

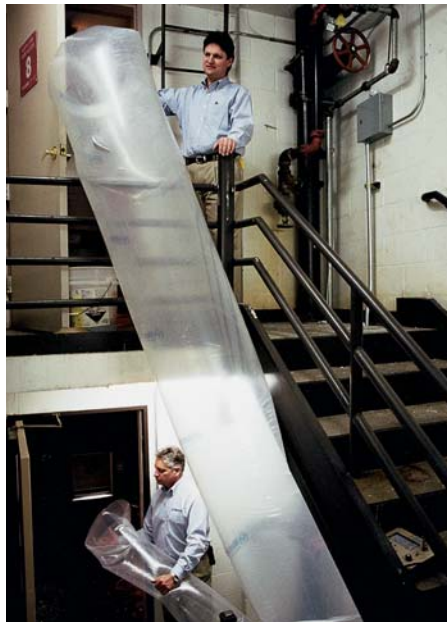
Munters stationed dehumidifiers outside and delivered dry air through the stairwells. Eight floors of guest rooms were dried simultaneously during the eight day project. Munters also saved racquetball courts, work-out facilities and the boiler room equipment.
