Million gallon flood at Federal Courthouse gets fast response.

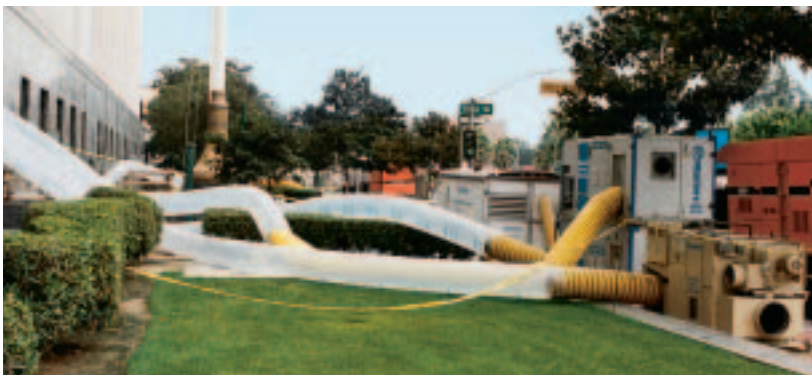
Munters was the only company that could start drying with the power to the courthouse shut off. Self-powered units were on site and drying before the basement was pumped.

Because Munters has mobile Emergency Response Units (ERU's) specially equipped to operate without external utilities, it is the only water damage recovery company always standing ready to handle a complicated project such as the LA Federal Courthouse. Munters was on the site within a few hours of Terrell's call. The Munters ERU's were supplying dry air into the flooded courthouse—thus stabilizing the building and beginning the dry out— even before the water was pumped out.

The self-contained drying systems carry high volume desiccant dehumidifiers, which have onboard propane gas and electrical generators. Munters tows them to the site, starts them up and begins drying—all without extra generators or utility hook ups. Not only did the courthouse staff get a fast start on the drying process, but the electrical vault—important to the city for blocks around—dried quickly, making it safer and easier for power company repair crews to work.

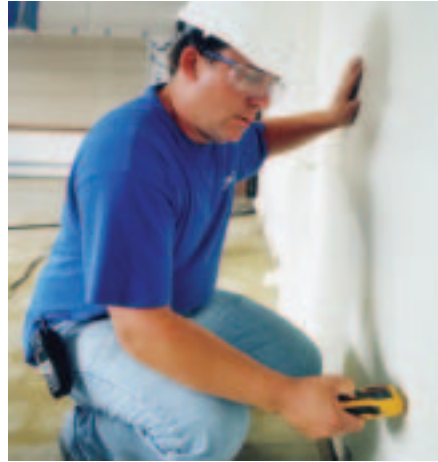
Munters measures moisture content of structural materials to determine if drying is thorough.

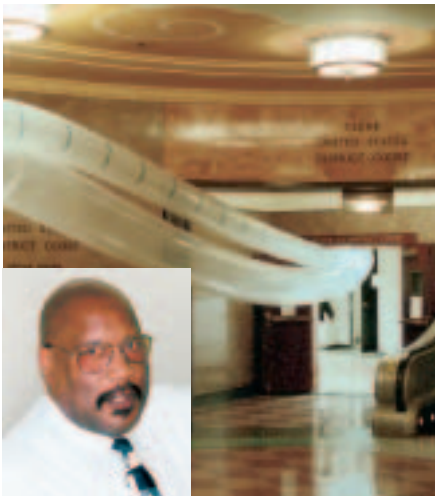
An estimated one million gallons of water poured through the lobby of the LA Federal Courthouse. Aaron Terrell called in Munters for fast action.
