CASE STUDY

STRUCTURAL DRYING: FAST RECOVERY NEEDED AFTER NFL STADIUM IS WATER DAMAGED NASHVILLE, TN

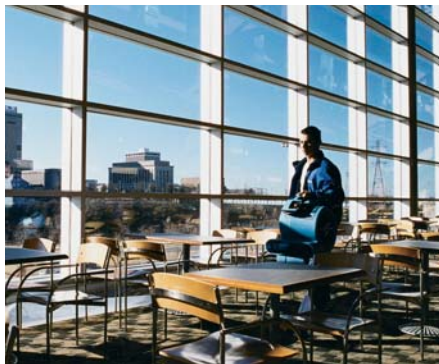
In the main concession area, a Munters technician places air movers to help circulate the dry air throughout a 150,000 sq. ft. open space. By game time, Munters had to have this massive area dry for thousands of Titans fans who expected to have lunch there before kickoff.

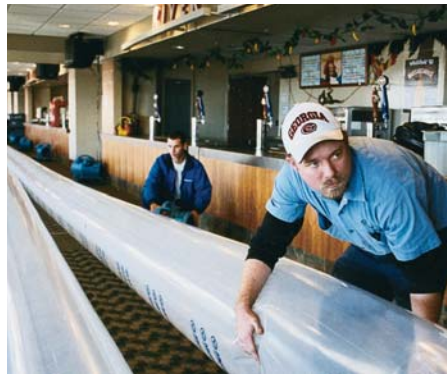
Dry air was brought into the concession area using light weight tubing, which can be quickly unrolled and then is inflated by the dehumidified air pumped through it. Hundreds of yards of tubing were needed to concentrate air at the wettest spots for fast drying.

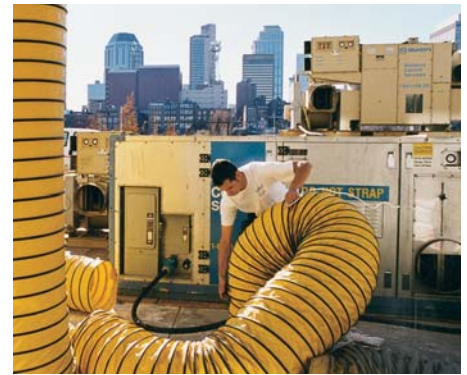
Grouped together outside, the fleet of large dehumidifiers was configured to funnel air into three main delivery ducts running up the side of the building. The ducts then went inside the building to different water-damaged areas.

Once on the scene, Munters placed a group of M-20 dehumidifiers outside the stadium. This centralized system pumped more than 30,000 cubic feet of dry air into the water damaged areas every minute! Beyond this another M-20 supplemented by 80 smaller dehumidifiers and a half-mile of ductwork addressed other areas in the stadium.
