Wentworth Institute saves 20 buildings after flood.

RESTORATION SERVICES Case Study: Multi-faceted Project

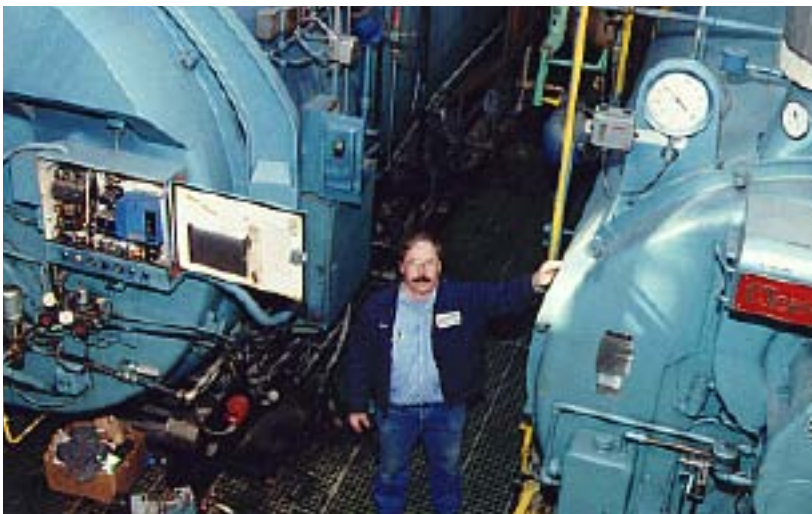
Jim Ammann points to the high-water mark in Wentworth's boiler room. Munters dried the boiler room, protecting the equipment. "We didn't even have to repaint it," said Ammann.

"The sewers overflowed into our boiler room," said Jim Ammann of the Wentworth Institute of Technology's building maintenance staff. "Before long we had seven feet of water surrounding our generation equipment, which knocked out all of the school's power." Without power, the pumping systems that usually kept Wentworth's 26 buildings dry during wet weather shut down. Twenty campus buildings suffered water damage, including the student center and the huge gymnasium. "It was amazing," recalls Ammann. "I was on the sandbagging crew and the water just poured in over our dikes and flooded over the gym floor in waves. We could do nothing to stop it. It was particularly frustrating, since the school had refinished the floor earlier that summer."

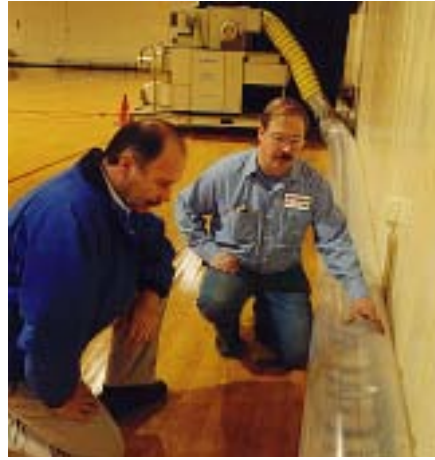
Jim Ammann inspects Munters gym floor drying configuration, which pumped dry air under the wet floor.

At Wentworth, Munters faced a wide variety of water damage problems. One of the more notable situations was the Wentworth gymnasium. The largest wood floor Munters has ever dried, it contains four, full size basketball courts. As soon as standing water was removed, the floor boards started to “cup” as a massive amount of water had flowed over it and run down through the cracks. However, two things were working in the floor’s favor: 1) Munters could start immediately, and 2) the floor’s high quality construction provided air spaces underneath it.”

Munters has successfully restored many different types of wooden floors, but those constructed with air spaces underneath provide the advantage of drying from above and below simultaneously. Using desiccant dehumidifiers integrated with other equipment to create a unique system, Munters circulated dehumidified air underneath the floor on one side of the gym, drew it across the entire width of the floor, and then extracted it on the other side.

“Munters procedure worked so well that the floor was restored without the need for refinishing. Before Munters completed the project, sports teams were on the floor,” said Ammann.

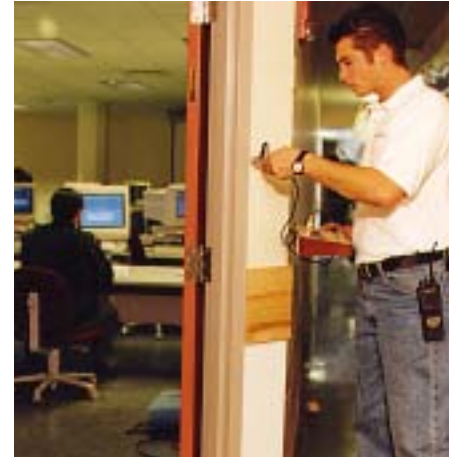
Computer centers were kept in use upstairs as drying continued downstairs.

Munters uses proven techniques and consults with experts in electronic restoration. At Wentworth, Munters protected a student computer center from corrosion, while drying a flooded downstairs area.
